Subject: First Beatty Inspection Fiscal Year 2016

The first inspection for fiscal year 2016 of the Beatty Low-Level Waste landfill (closed) was conducted on October 21, 2015. The radiological survey was performed by walking a BNC Model RD-120 GN radiation detection system in a grid pattern across the surface of the site (i.e., the cap) to detect radiological anomalies. No anomalies were detected. Dose rate readings on the cap remain about twice background as read on surrounding areas. This is consistent with previous surveys.

Beatty Inspection 10-21-15

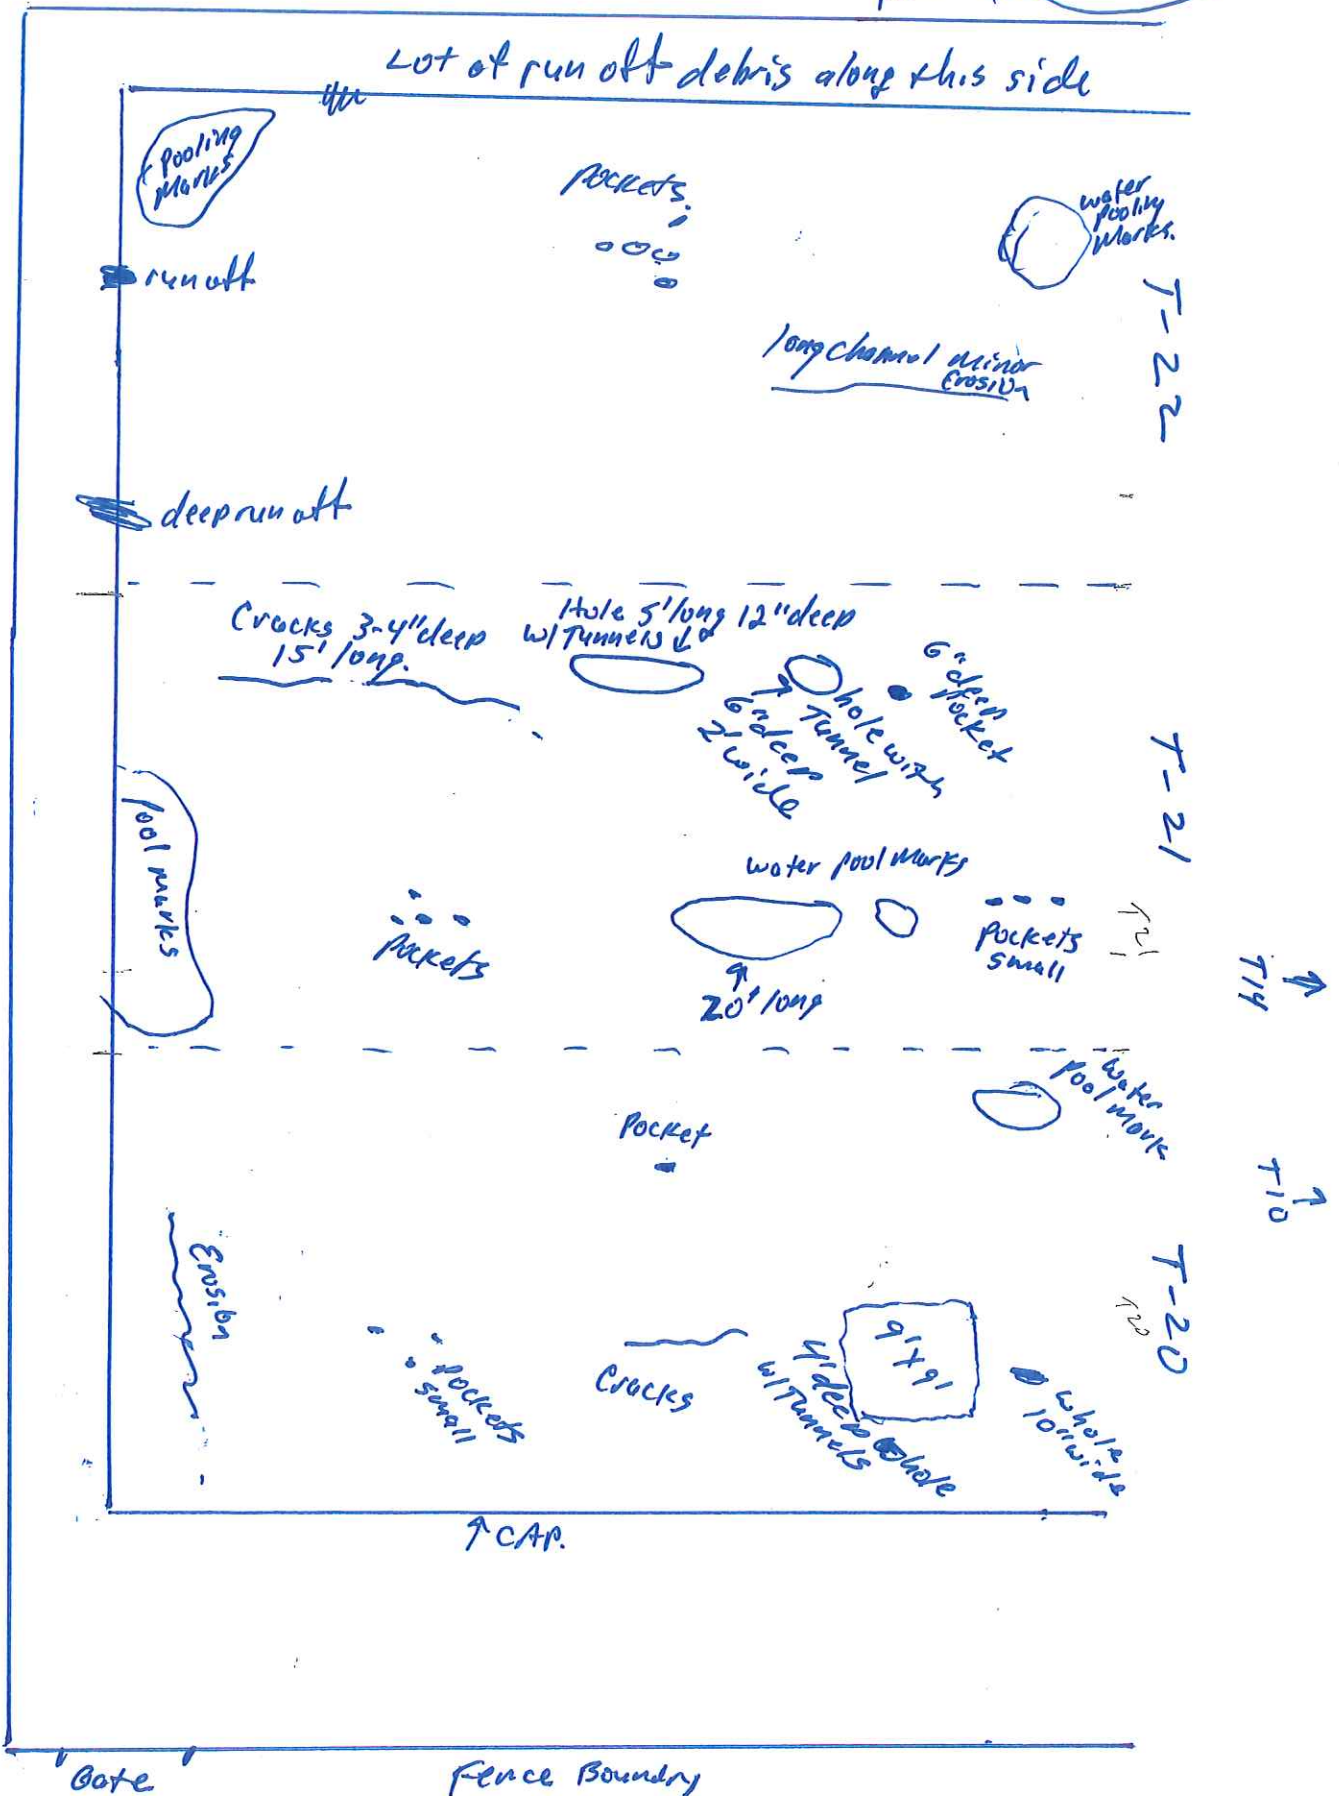
The inspection was performed following an incident that involved a fire at the site on Sunday, October 18, 2015. In addition to the damage associated with the fire, which occurred near trench number 14, additional erosion was noted at the site as listed below:

- Trench 20, there is a large square shaped whole approximately 9ft. X 9ft., about 4ft. deep. There are visible tunnels that run deeper than 4ft. Repairing this whole should be a high priority with regards to repairing the cap.
- Trench 20 has additional erosion sites of crack and pocket type holes.
- Trench 21 has three holes between 6in. and 24in. across and anywhere from 6in. to 12in. deep, there are also channels/cracks that range from 5ft. to 15ft. long and have depths from 3in. to 12in., and one has a deep tunnel running further underground.
- Trench 22 has cracks and there is erosion and runoff debris along the edge of the site down to the fence boundary.
- Trench 14 has a large erosion area that consists of a channel that is roughly J shaped and contains holes with deep tunnels. The size of the erosion is about 24ft. X 28ft.

It should also be noted that the cap has a relatively flat surface (not domed or very sloped). As a result, there are areas within the cap where water has pooled. Water appears to be moving under

the surface of the cap through tunnels that are not visible from the surface until a subsidence occurs.

It was also noted that during the last repair of the cap, some of the trench markers may have been moved.

Large pool of water  
outside fence  
boundary

Lot of run off debris along this side
