Subject: Beatty Inspection Summary February 26, 2019

An inspection of the Beatty Low-Level Radioactive Waste landfill (closed) was conducted on February 26, 2018 by John Follette. The radiological survey was performed by driving the BNC Model SAMpack-120 (BSN 120064) backpack around the site boundary access road and in a grid pattern across the cap to detect radiological anomalies. None were detected. Dose rate readings on the cap remain about twice background\*, as read on the access road.

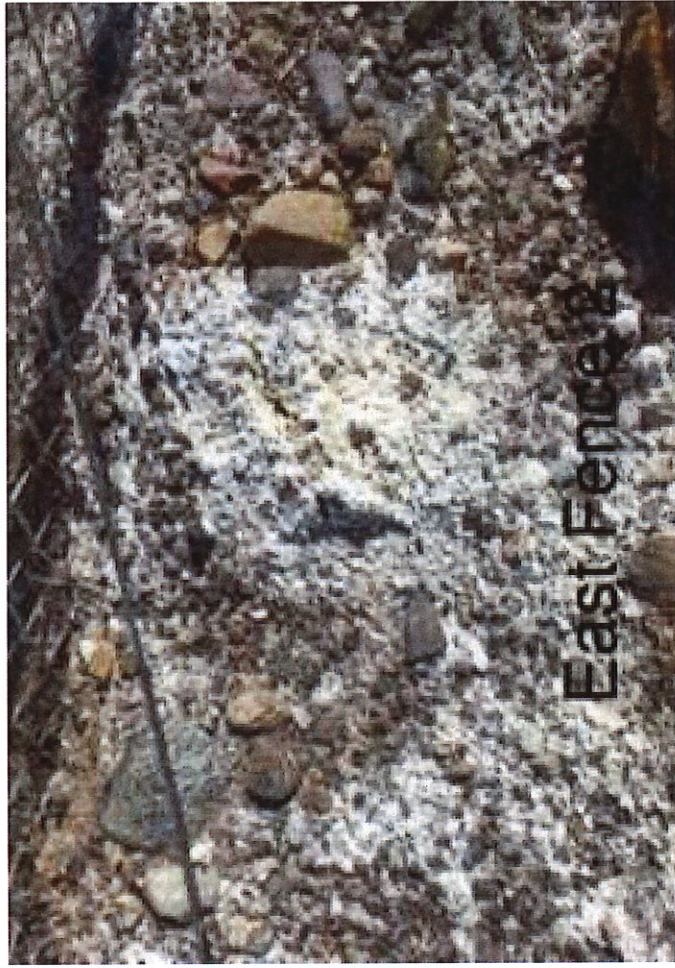
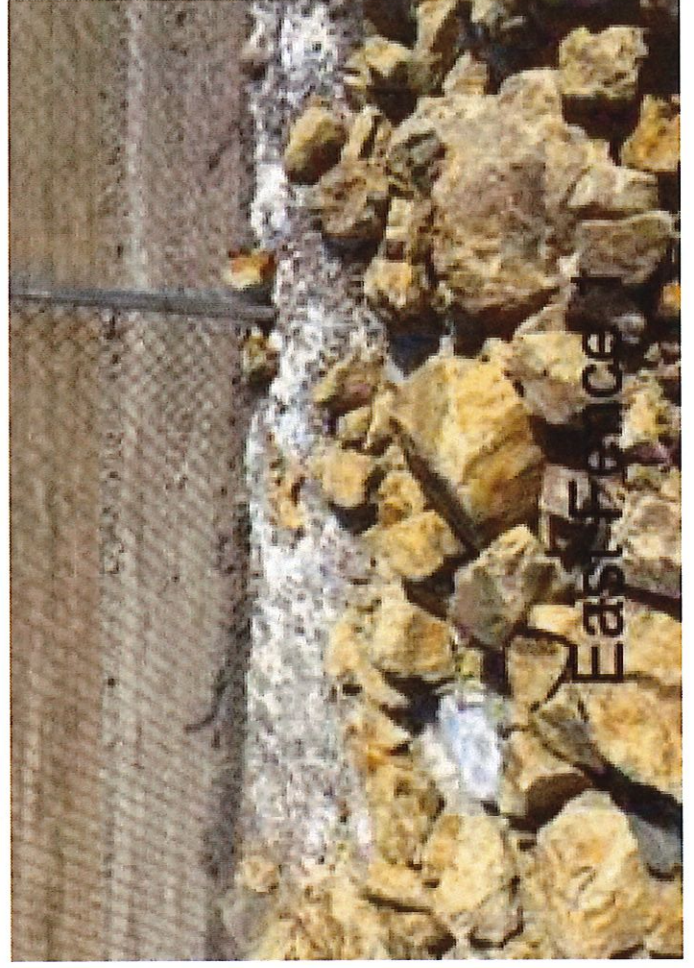
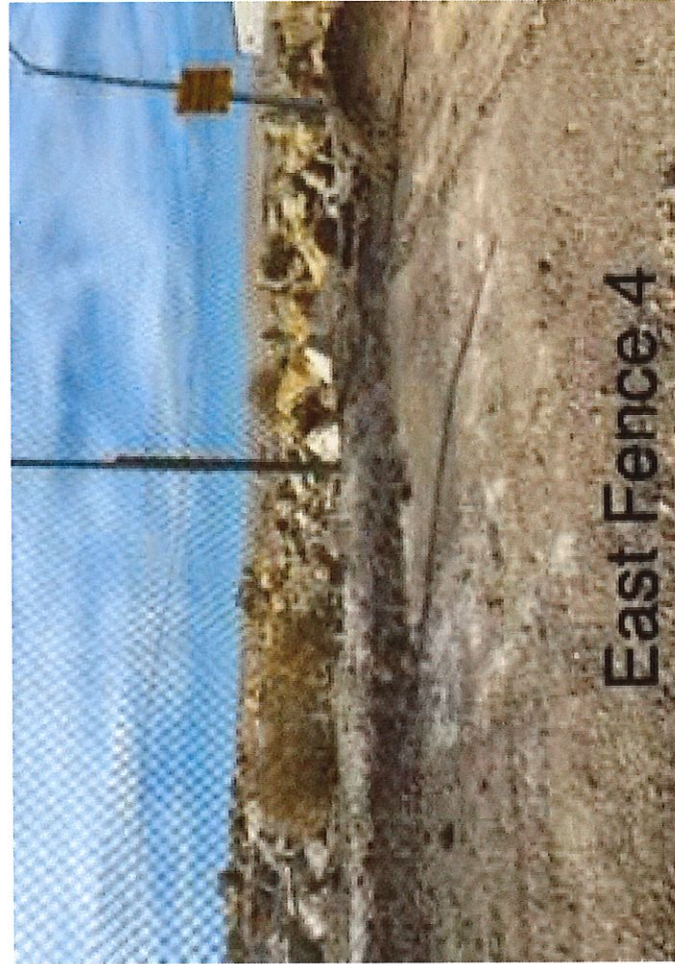
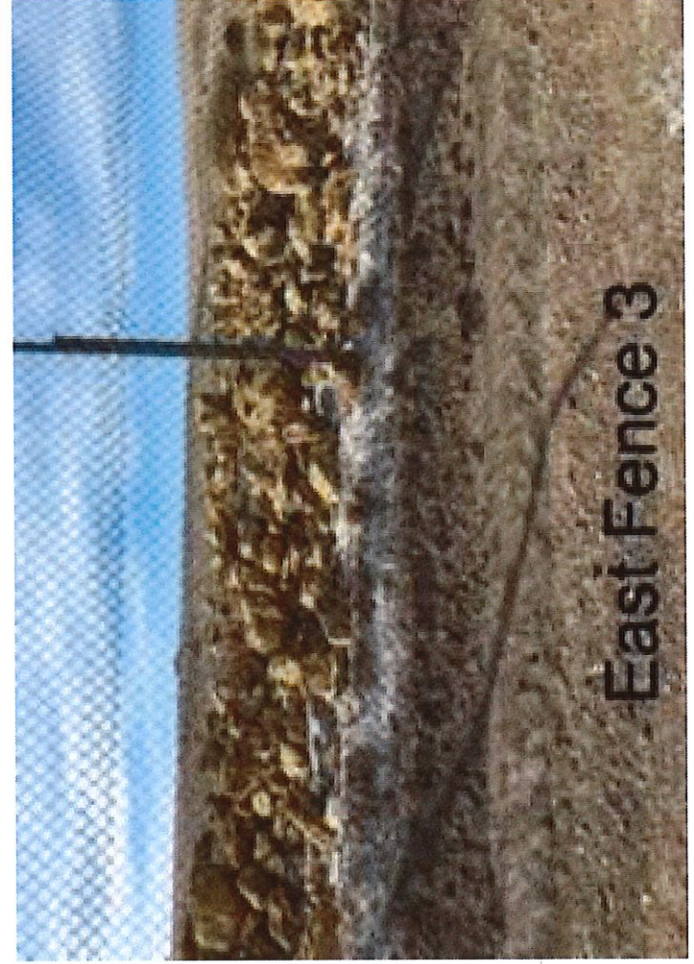
Patches of white crust have formed on the surface around trench 14 along the east fence of the site. The area affected is about 60 feet long and the width varies between 2 to 10 feet wide. The white crust is the same type that was previously identified during inspections on February 17, 2016 and April 18, 2016. The crust was previously assumed to be hydroxides that are seeping up from the surface. USEN previously cleaned up these areas, however, the hydroxides continue to seep to the surface.
